# Newmar Corporation

**RSB 550**  
**Sep. 17, 2019**

**NHTSA #19V 610**  
**TC #2019-417**

## Recall 19V 610 Work Instructions: Securing the Bedroom Fascia Header

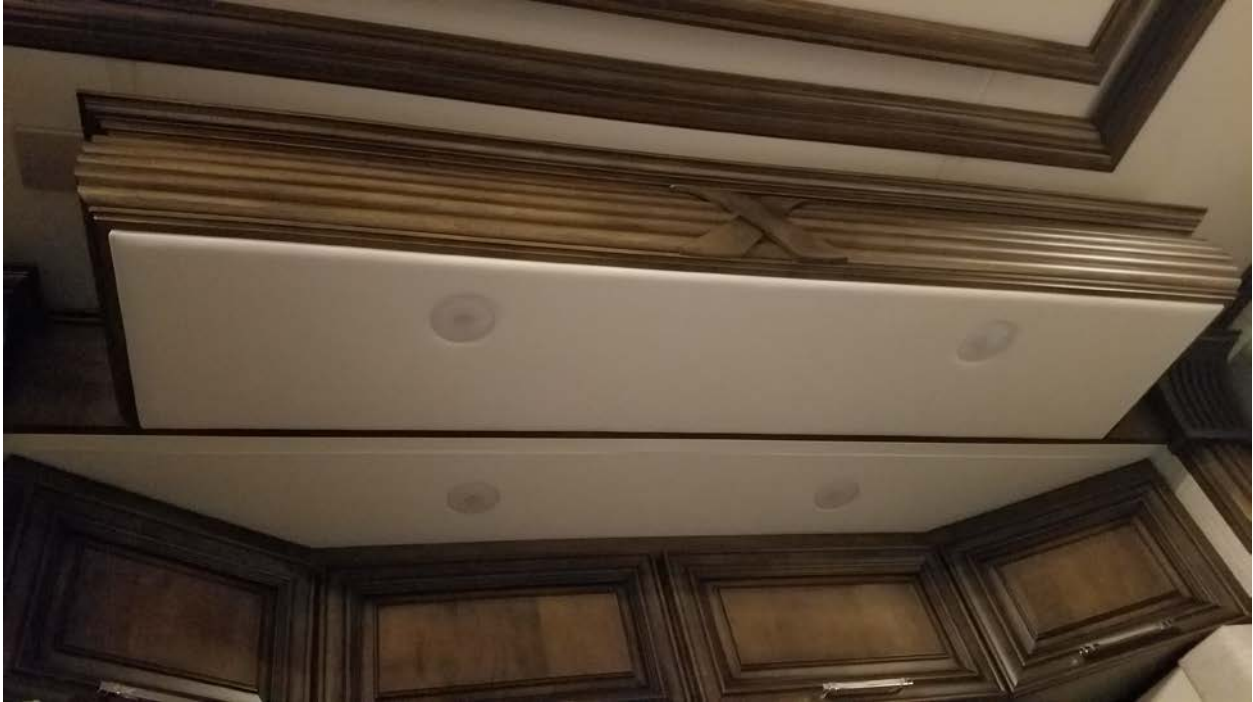
1. Order eight brackets (Newmar part # 62122) and 16 screws (5/8", Newmar part # 138326).

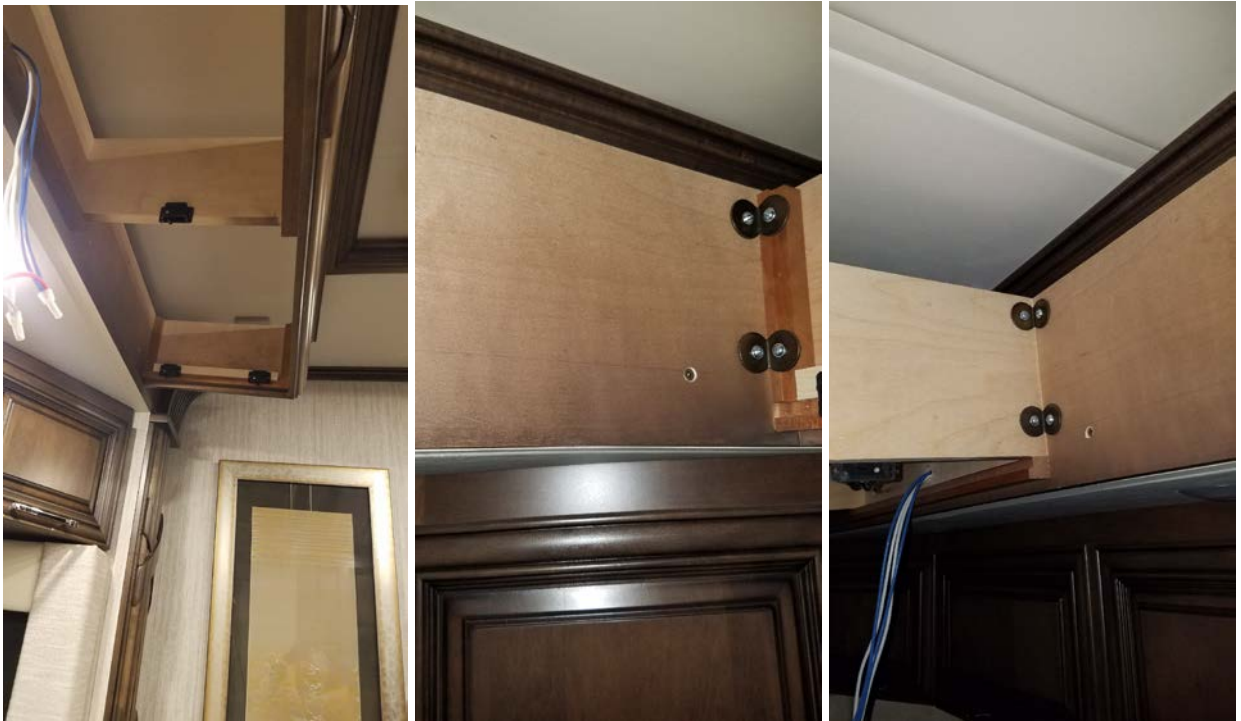
2. Pull down the padded panel from the bedroom fascia header. It is secured using black Southco latches.
